EXCEL SERIES

Maintenance & Repair Manual General Body & Hydraulics

Released June 28, 2007
This manual is publication 7700043

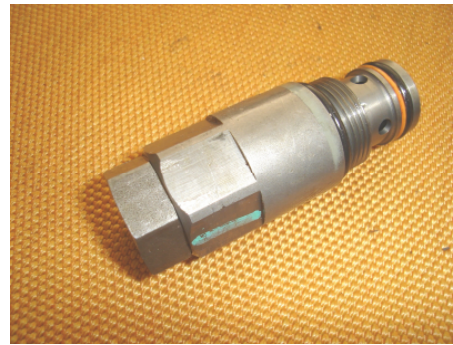
Actually, there is no commonly available method to field "check" where this relief is set. This is because it is "test-stand set" at its *crack* value of 3800 PSI @ 2 GPM. If you suspect that this port mounted relief is not correct, it is most practical to order from LOADMASTER a brand new bench set cartridge.

VG35 PORT RELIEF
